NATIONAL TRANSPORTATION SAFETY BOARD

AIRCRAFT ACCIDENT REPORT

**OVERSPEED AND LOSS OF POWER
ON BOTH ENGINES DURING DESCENT AND
POWER-OFF EMERGENCY LANDING**

**SIMMONS AIRLINES, INC., d/b/a
AMERICAN EAGLE FLIGHT 3641, N349SB
FALSE RIVER AIR PARK, NEW ROADS, LOUISIANA
FEBRUARY 1, 1994**

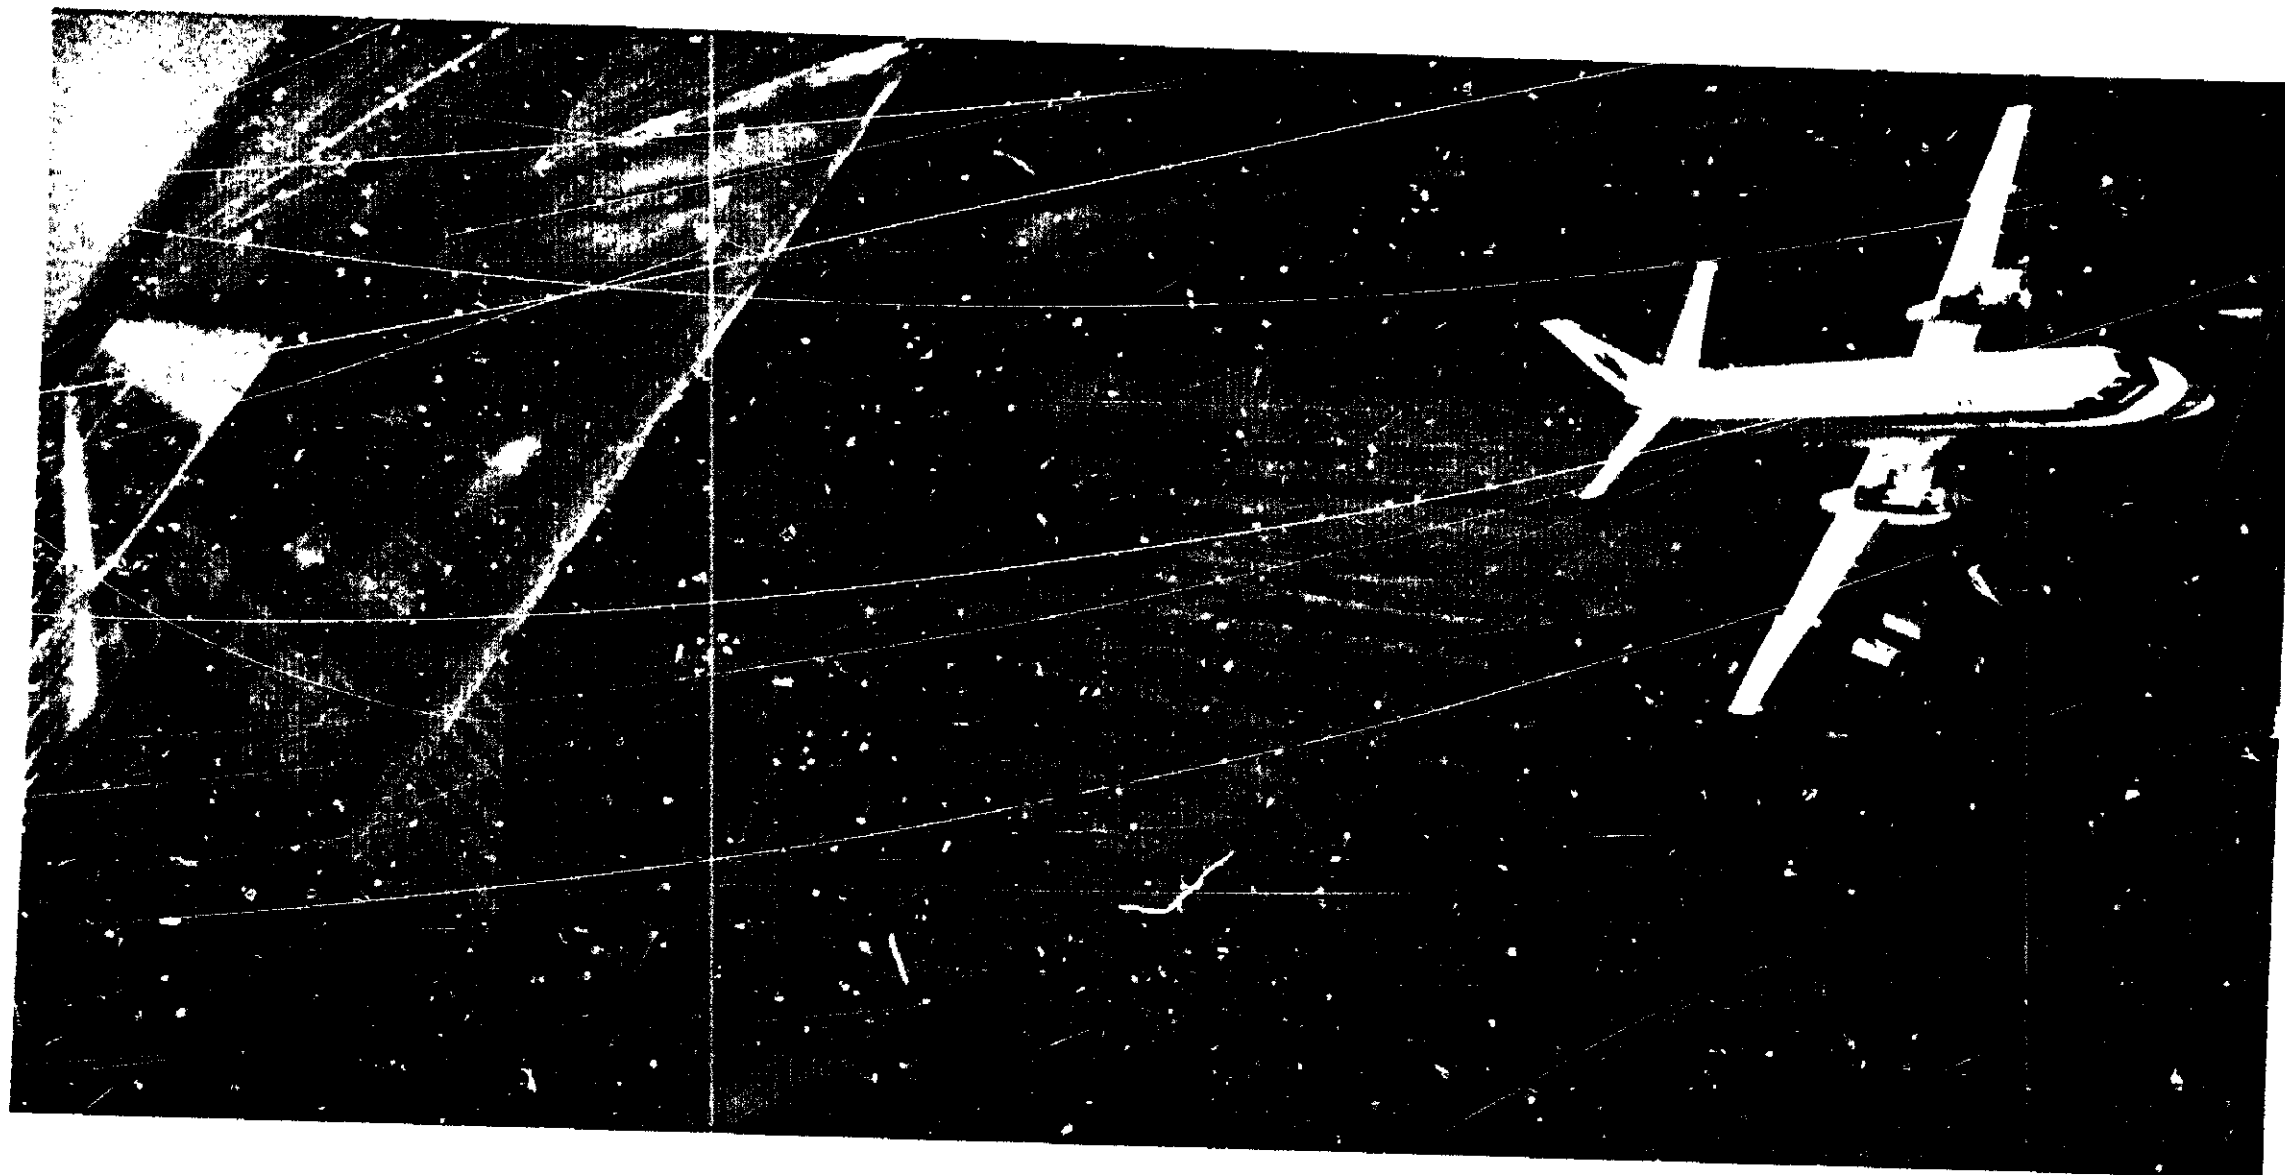
Figure 1.--Resting position of airplane.

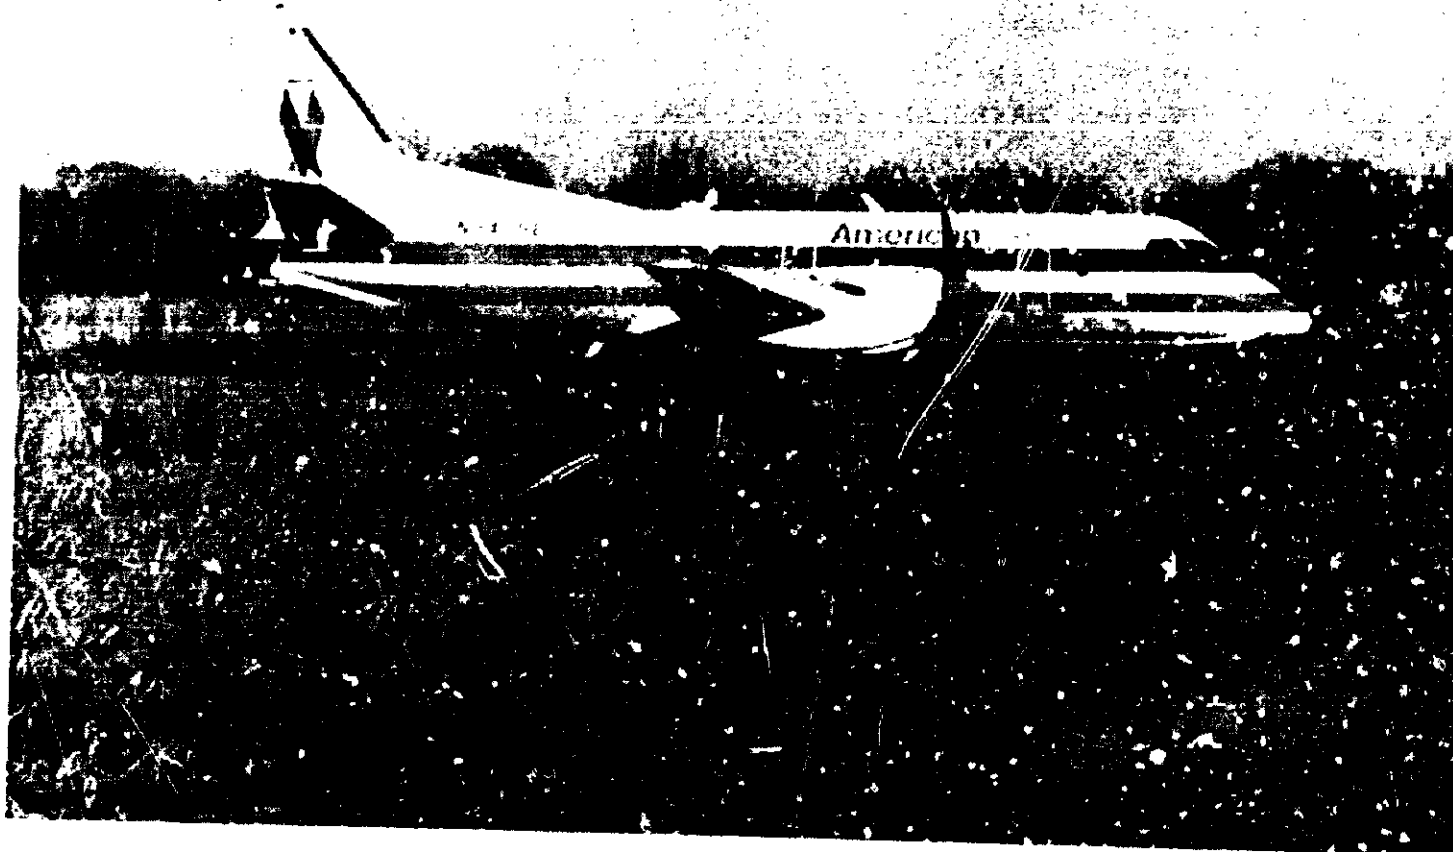
Figure 2a.--Airplane in sugar cane field with fence visible on landing gear.

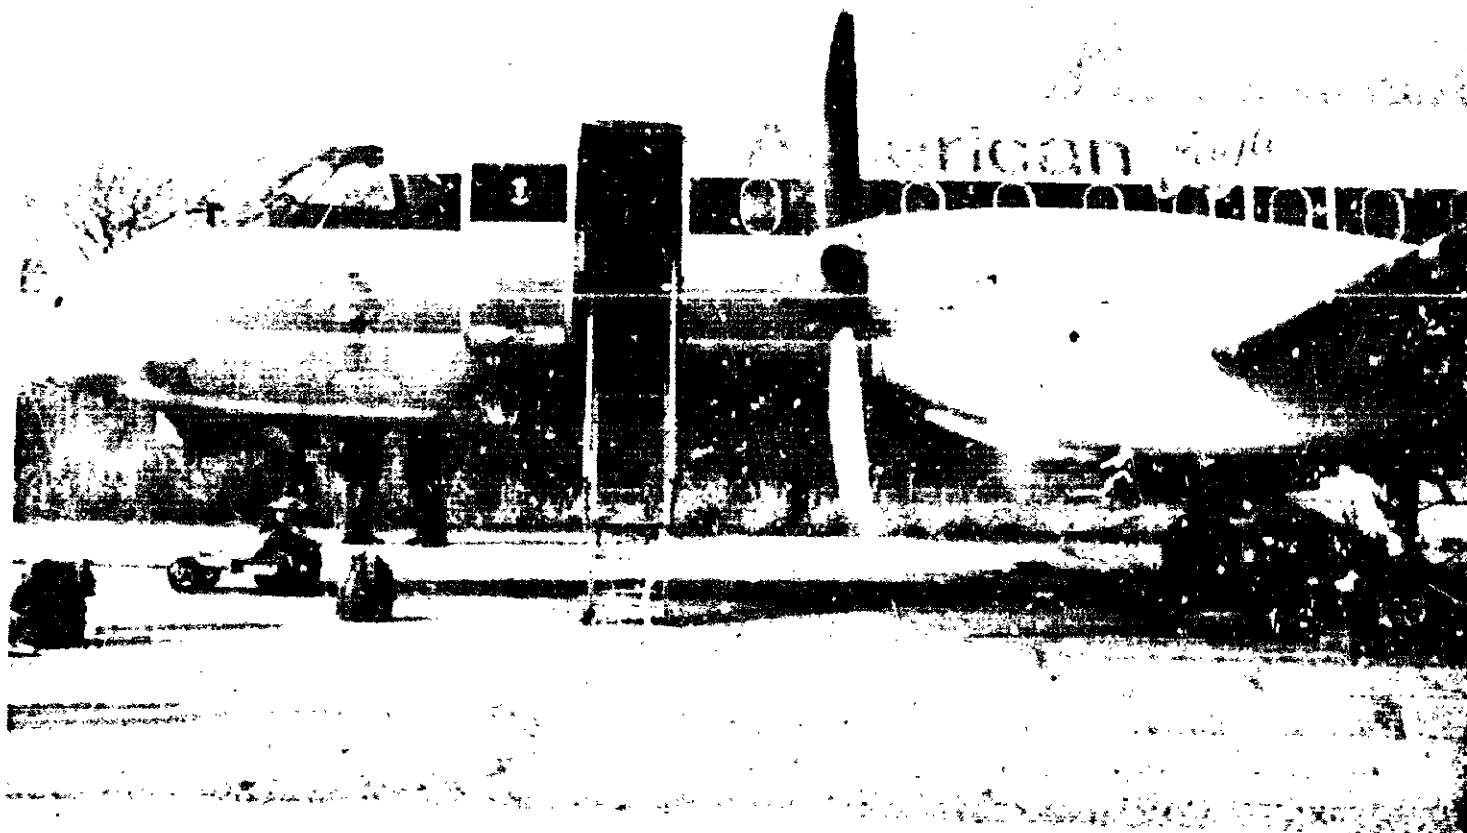
Figure 2b.--Airplane after recovery showing radome, puncture (in front of logo), and dented leading edge of wing.

Structural damage to the airplane included dents and punctures in wing leading edge panels and flap panels, a horizontal crease in the left nose structure at the radome, and crushing of the composite radome. There was a 2- by 3-inch hole surrounded by a 6- by 12-inch dent in the fuselage aft of the main cabin door upper edge. Also, there was a 3-inch tear near the forward hinge point for the right nose landing gear door, a buckled skin and former section on the left side of the left nacelle, and a bend in the lower forward spar cap at the root of the left wing. Figures 4a and 4b illustrate the wreckage site and damage to the airplane.

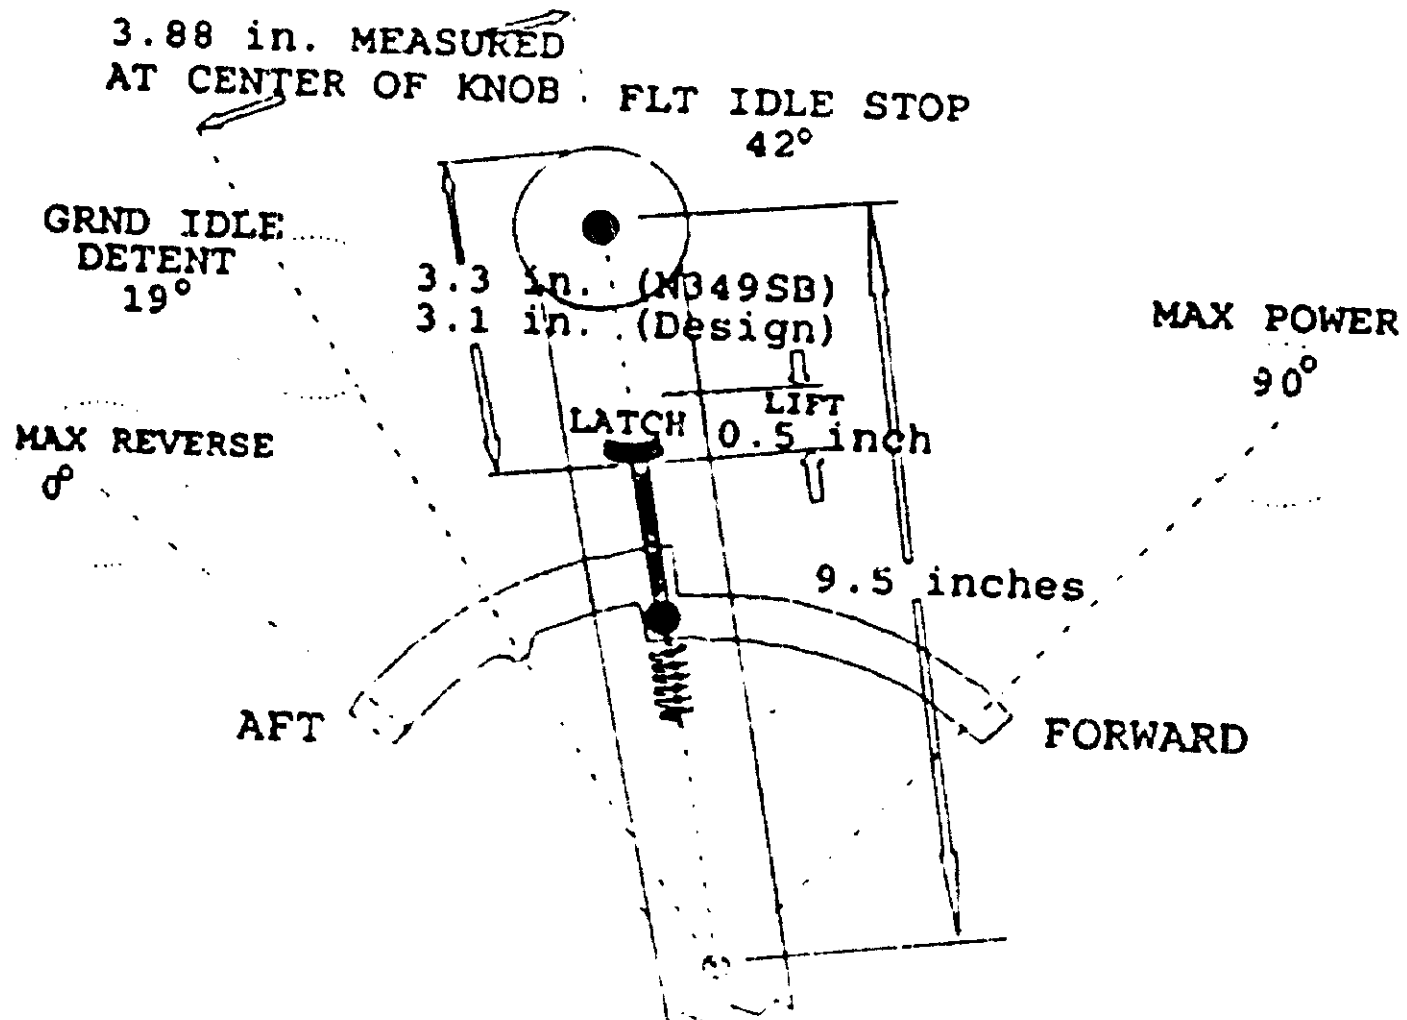
1. Left latch movement began with 3.0 pounds of lift and topped at 7.0 pounds.
Right latch movement began with 3.0 pounds of lift and topped at 5.5 pounds.
Saab design calls for beginning of 2.5 pounds and 7.0 pounds at .5 inch lift.
2. Dimensions measured on N349SB and confirmed with Saab documents.

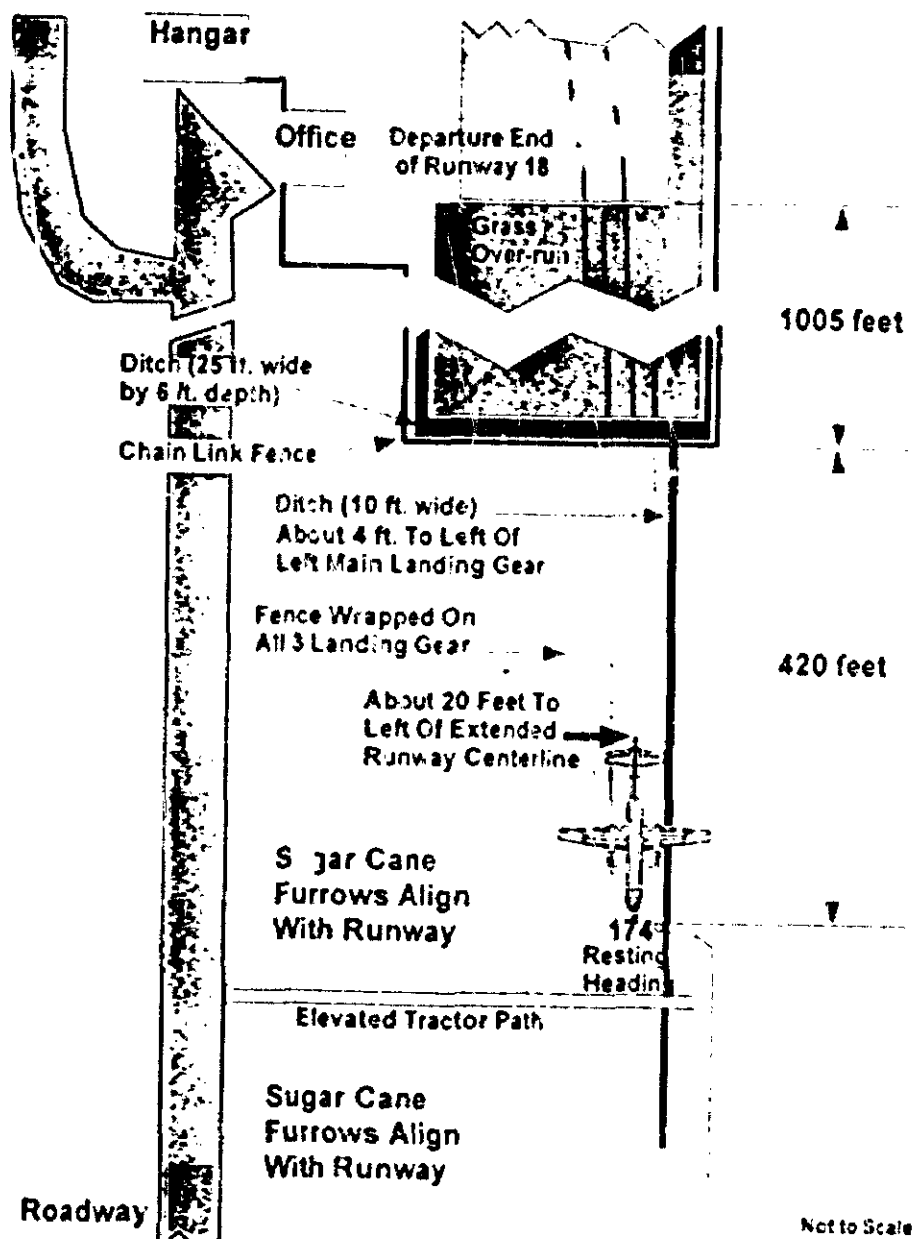
Figure 4a.--Wreckage site and airplane damage.

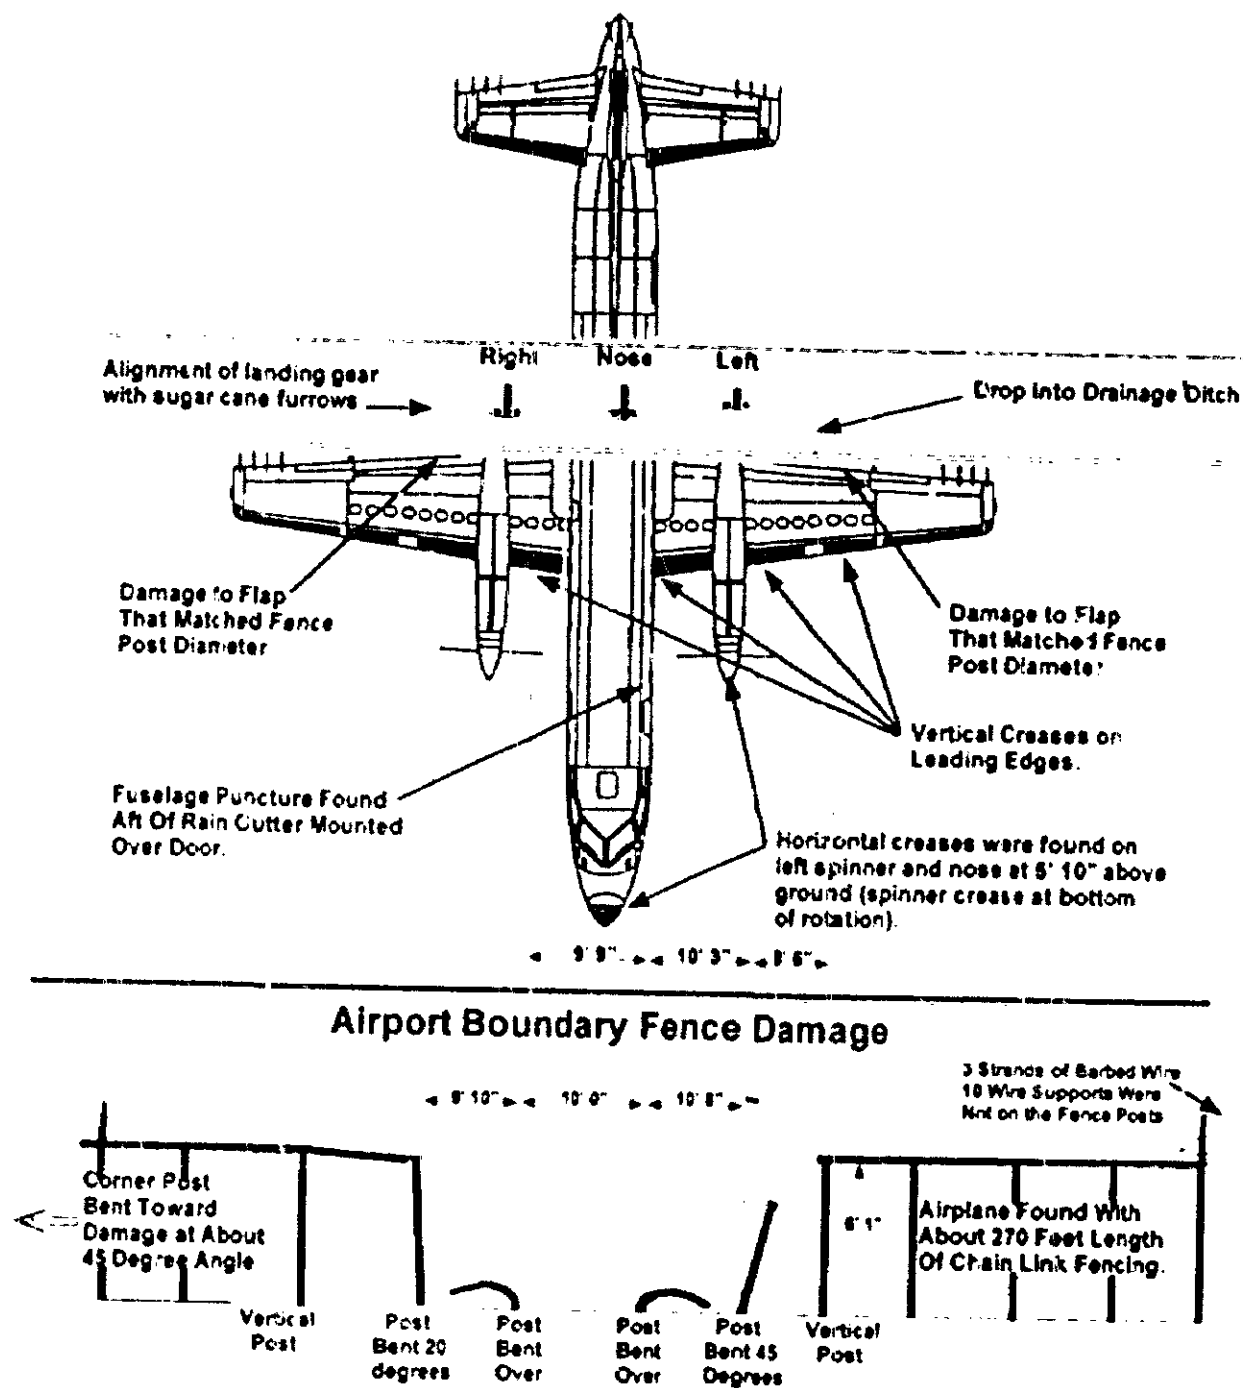
Figure 4b.--Wreckage site and airplane damage.
